2016 VOLVO D13

Super-D® FE Engine Teardown Results

This 2016 Volvo D13 powered a rig in coast-to-coast operation using a tandem driving team from a Youngstown, Ohio area fleet. Oil drains were at 30,000 miles using Kendall® Super-D® FE 10W-30 (FA-4), accumulating 762,000 miles at the time of tear down. Performance is notable in that Volvo does not endorse the use of FA-4 oils.

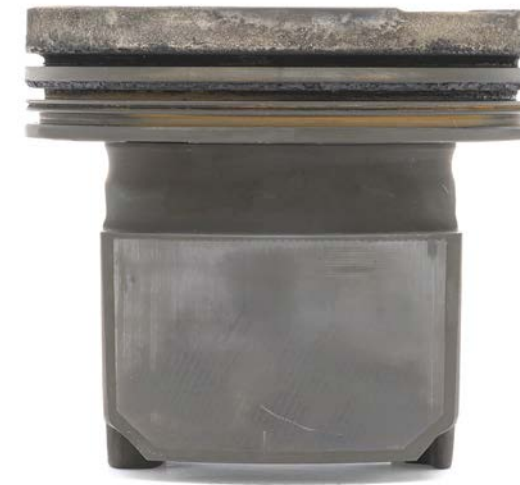
Piston 1 - Thrust

Engines accumulating this kind of mileage in heavy haul service would typically exhibit varying amounts of medium and heavy carbon deposits in the ring grooves. In this case there is only light carbon and virtually no piston skirt scuffing. Kendall Super-D FE 10W-30 protects where it counts.

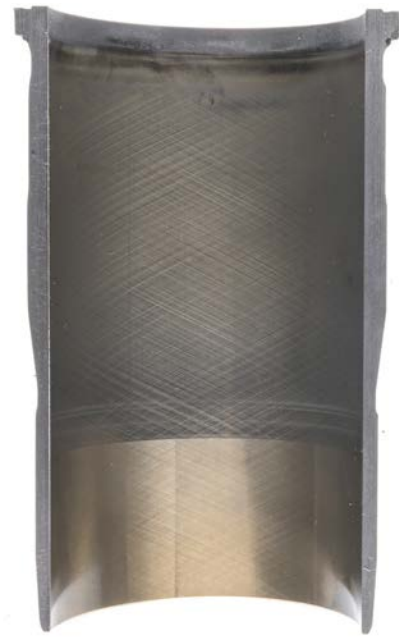
Liner 1A

Cylinder liners are subject to extensive heat and friction over the life of an engine. These representative examples show they are free from scuffing (cross-hatching looks great) and there's very minimal wear in the ring turn-around zone.

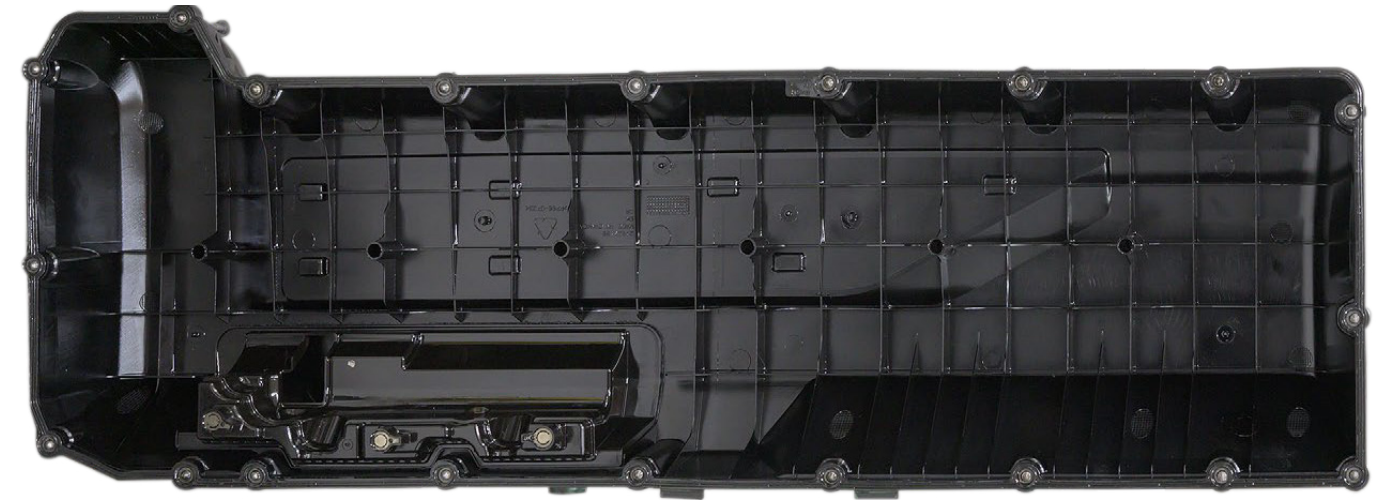
Rocker Cover

The oil pan and rocker cover are where sludge is often found in engine teardowns. Close inspection of the photos here tell a different story.

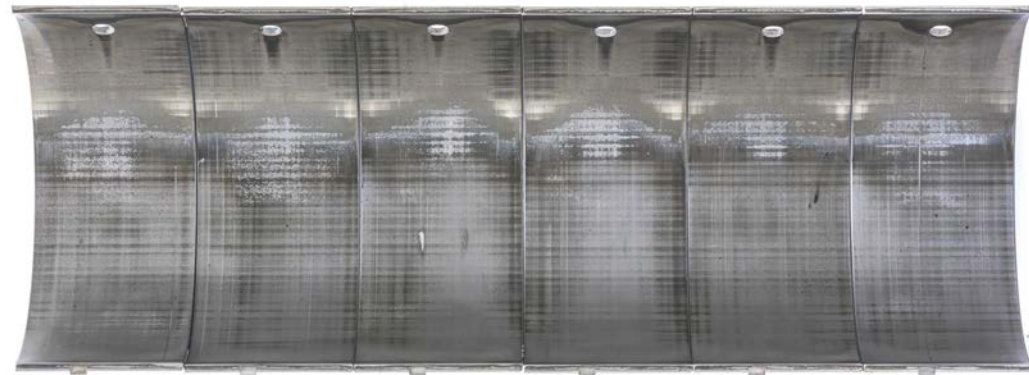
Rod Bearing Upper

Rod bearings show little to no wear. Kendall® Super-D® FE 10W-30 provides maximum durability.

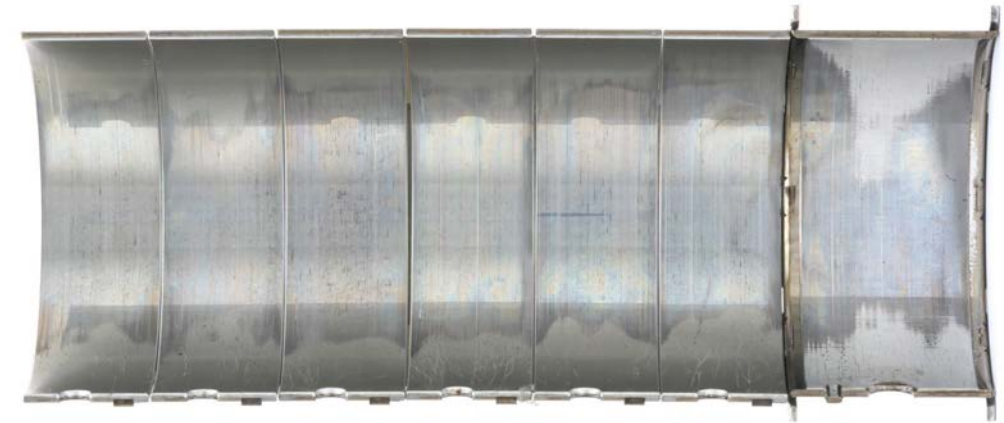
Cam Bearing Upper

Because the Volvo cam shaft is larger than most other manufacturers, performance here is critical. Effective film strength of our FA-4 10W-30 provides all the protection you need to assure long life of the engine.
