2016 VOLVO D13

Super-D® FE Engine Teardown Results

This 2016 Volvo D13 powered a rig in coast-to-coast operation using a tandem driving team from a Youngstown, Ohio area fleet. Oil drains were at 30,000 miles using Kendall® Super-D® FE 10W-30 (FA-4), accumulating 762,000 miles at the time of tear down. Performance is notable in that Volvo does not endorse the use of FA-4 oils.

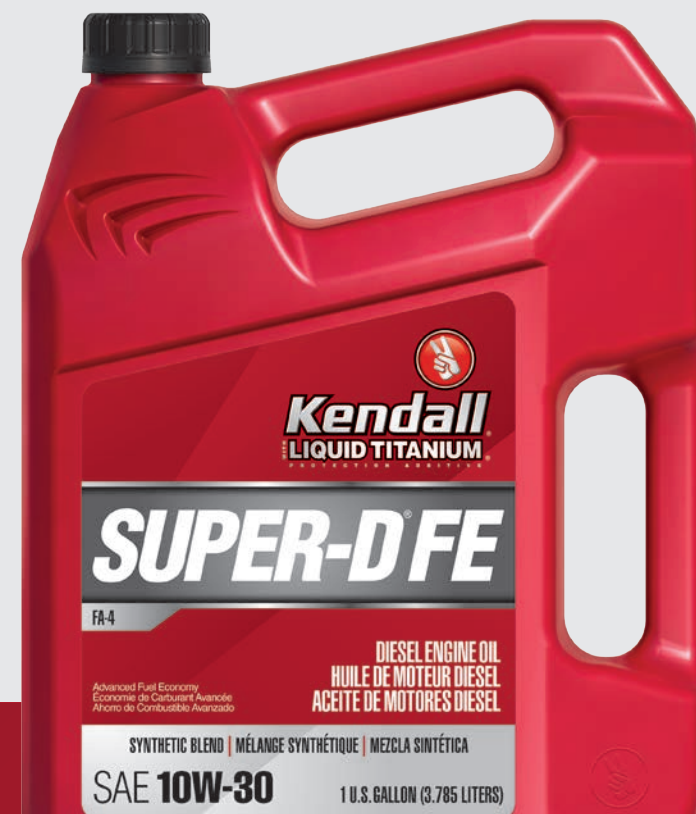
Engines accumulating this kind of mileage in heavy haul service would typically exhibit varying amounts of medium and heavy carbon deposits in the ring grooves. In this case there is only light carbon and virtually no piston skirt scuffing. Kendall Super-D FE 10W-30 protects where it counts.
