2014 PACCCAR MX-13

Super-D® FE Engine Teardown Results

These parts were pulled from a 2014 PACCAR MX-13 pulling a refrigerated trailer in coast-to-coast service from its base in the southeastern US. Oil drains were at 45,000 mile intervals using Kendall® Super-D® FE 10W-30 (FA-4). Tear down was performed in 2017 after quickly accumulating 500,000 miles.

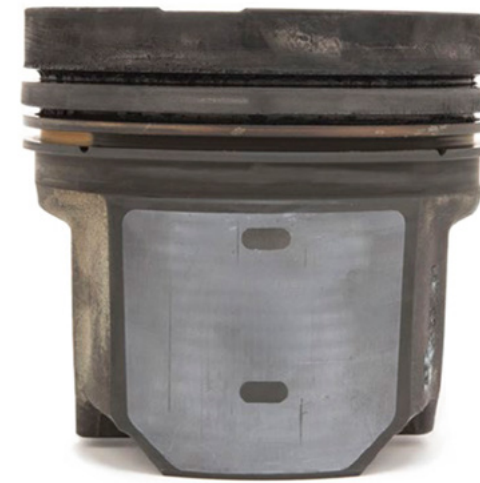
Piston 1 - Thrust

500,000 miles is when many fleets begin considering whether to sell a truck or end a lease. The pistons show very little carbon deposits in the ring grooves and no piston skirt scuffing. Super-D FE 10W-30 provides assurance that your equipment is protected for the long haul.

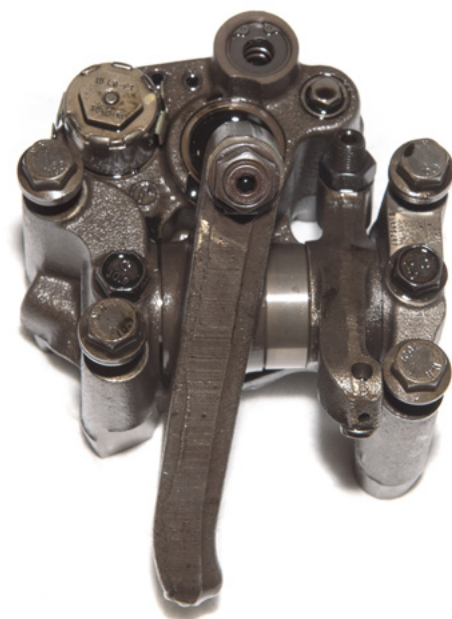
Valve Train Component

Minimal wear scars on critical valve train components indicate excellent anti-wear protection from Kendall® Super-D® FE 10W-30 (FA-4).

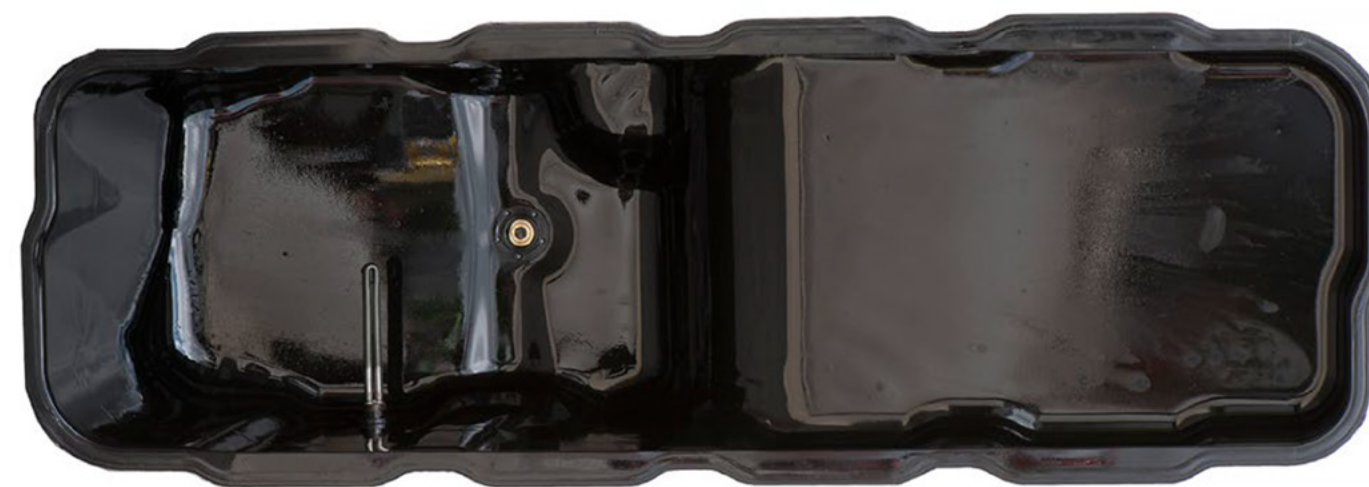
Oil Pan

The oil pan is where sludge is often found in engine teardowns. Close inspection of the photo here tells a different story.

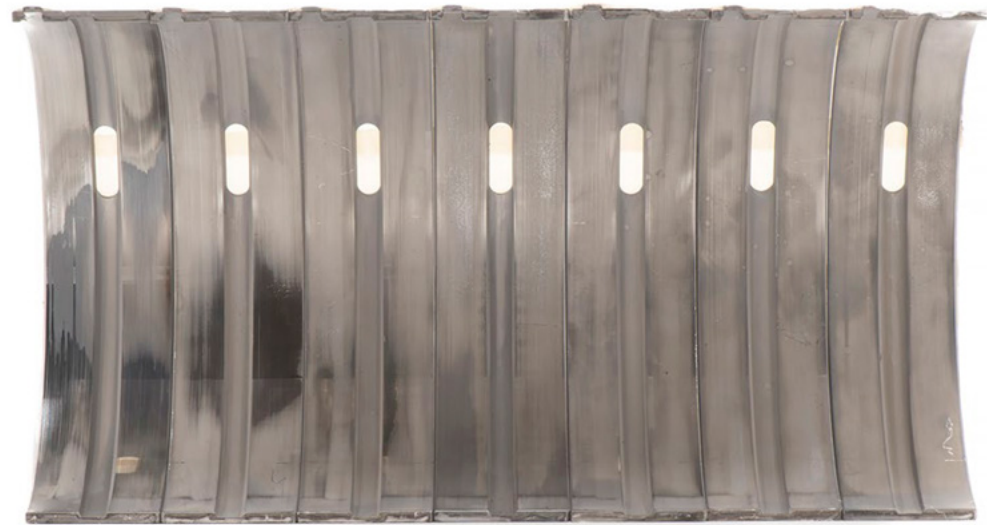
Main Bearing Upper

Bearings are where a poor performing product would quickly be exposed. The excellent High Temperature/High Shear (HTHS) properties of our FA-4 oil provide protection equivalent to our premium CK-4 15W-40.

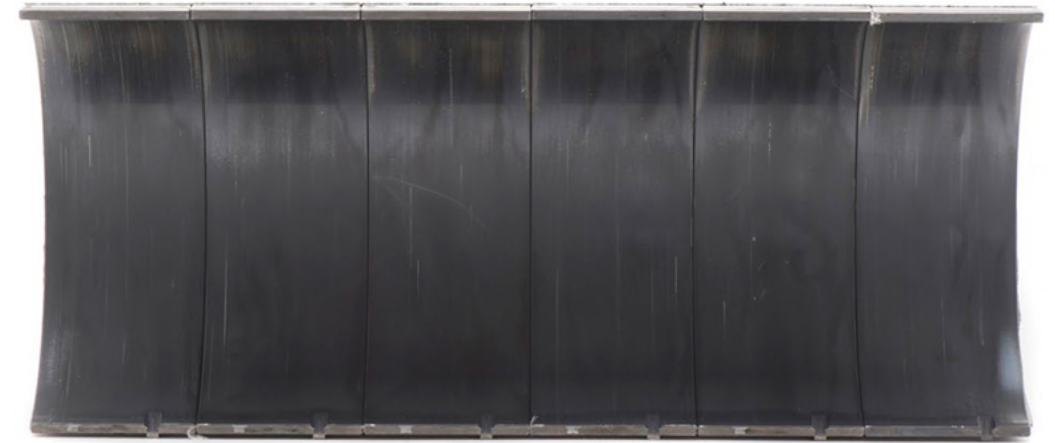
Rod Bearing Upper

Rod bearings show little to no wear. Kendall® Super-D® FE 10W-30 provides maximum durability.
